Document type
Environmental monitoring report Q3/2010

NORD STREAM GAS PIPELINE CONSTRUCTION AND OPERATION IN THE FINNISH EEZ

ENVIRONMENTAL MONITORING Q3/2010

Ref G-PE-EMS-MON-100-0304ENG0-B

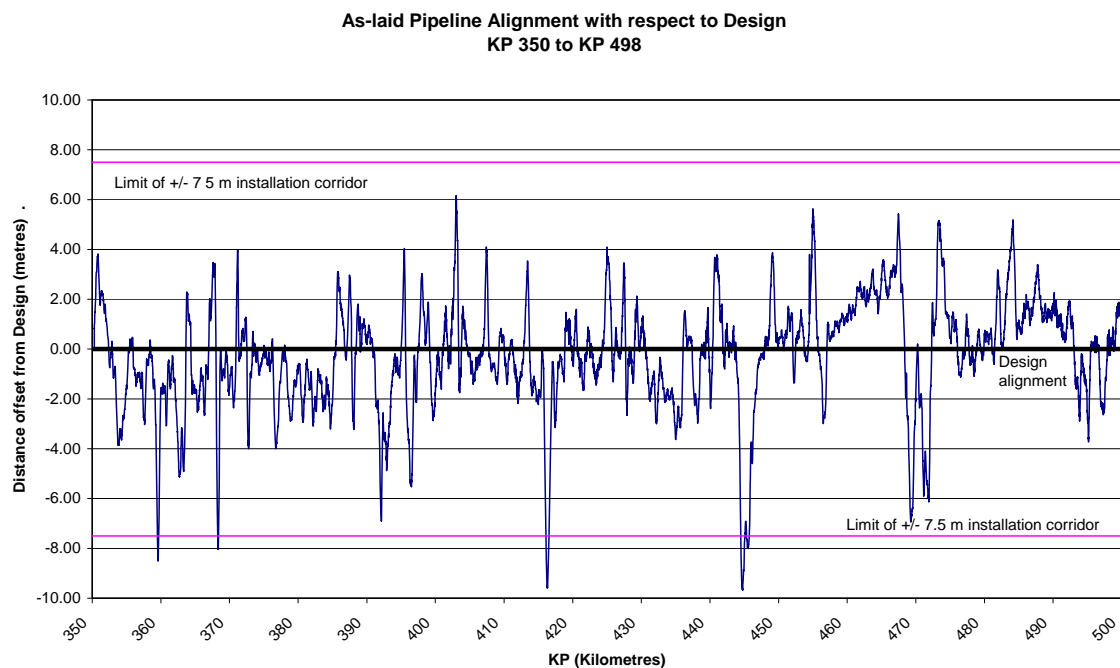
Figure 6.7 As-laid pipeline alignment with respect to design from KP 350 to KP 498

Consequently over a length of 177 m between KP 359.499 and KP 359.676 the pipeline has been installed out with the permit provision (Appendix 5). The reason for this deviation was to ensure pipeline integrity by avoiding three boulders located within the installation corridor during the pre-lay survey at KP 359.573, KP 359.564 and KP 359.558.

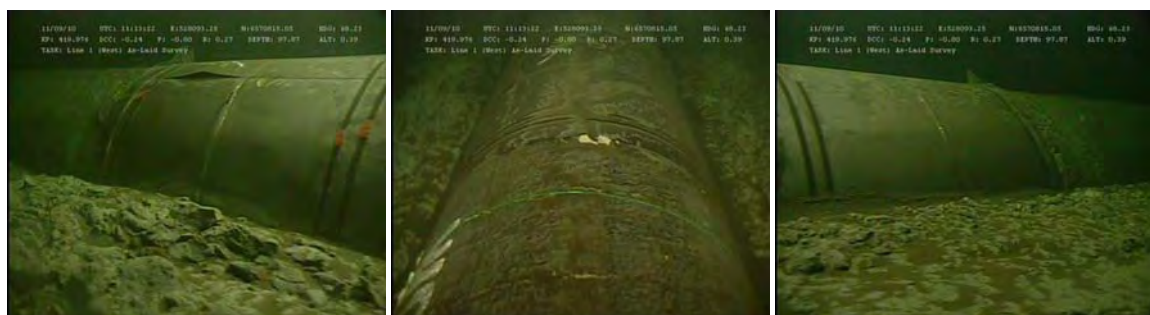
As-laid pipeline profile from KP 350 to KP 498 is generally slightly deeper than predicted in the design. This is due to higher pipeline embedment observed over the majority of the section. Figure 6.8 shows an example of an approximately 50 % embedded pipe at KP 420. The higher embedment is most likely a result of conservatively considering the upper bound soil properties (stiffer than actual) for design.

Figure 6.8 Field joint showing approximate 50% pipeline embedment at KP 419.975

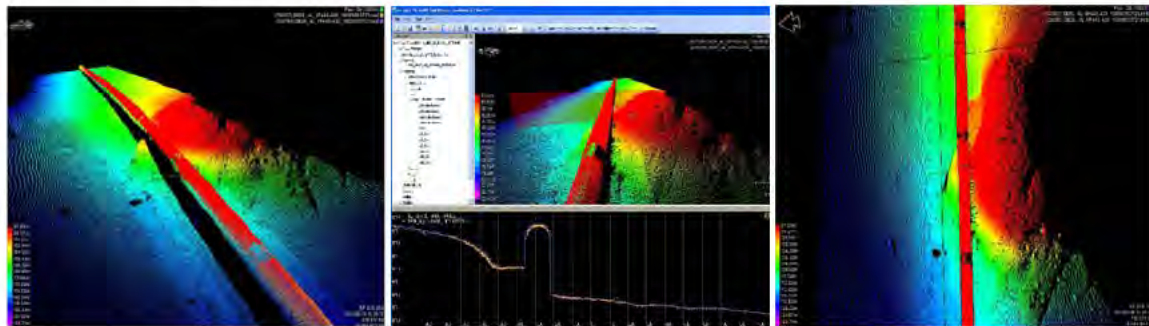
Based on comparisons of pipeline as-laid and design data, the as-laid freespans are generally shorter than design freespans, with the following main exceptions: KP 359.69, KP 367.09, KP 438.25 (Figure 6.9), KP 447.6, KP 448.2, KP 467.7, KP 478.7, KP 481.3, KP 491.3 and KP 496.1.

Figure 6.9 Freespan from KP438.167 to KP438.369 (length 202 m and maximum height 2.30 m). Pipeline traversing the edge of seabed mound at KP438.254.

Based on the engineering assessment of the as-laid configuration of the pipeline from KP 350 to KP 498 only three of the fourteen design post-lay rock placement works are still required, namely W2373 (KP 368.6), W2341 (KP 438.3), W2347 (KP 452.0). Six rock berms not foreseen in the design have been added for pipeline flooding, pressure test and operating conditions. These berms are W2379 (KP 354.621), W2380 (KP 367.050), W2381 (KP 367.116), W2382 (KP 368.512), W2378 (KP 438.240) and W2645 (KP 467.153). Berm W2645 is required for fatigue in long term (operation) condition and may be installed during the Phase 3 rock placement (after dewatering), whereas the other berms will be installed during Phase 2 rock placement (before flooding).

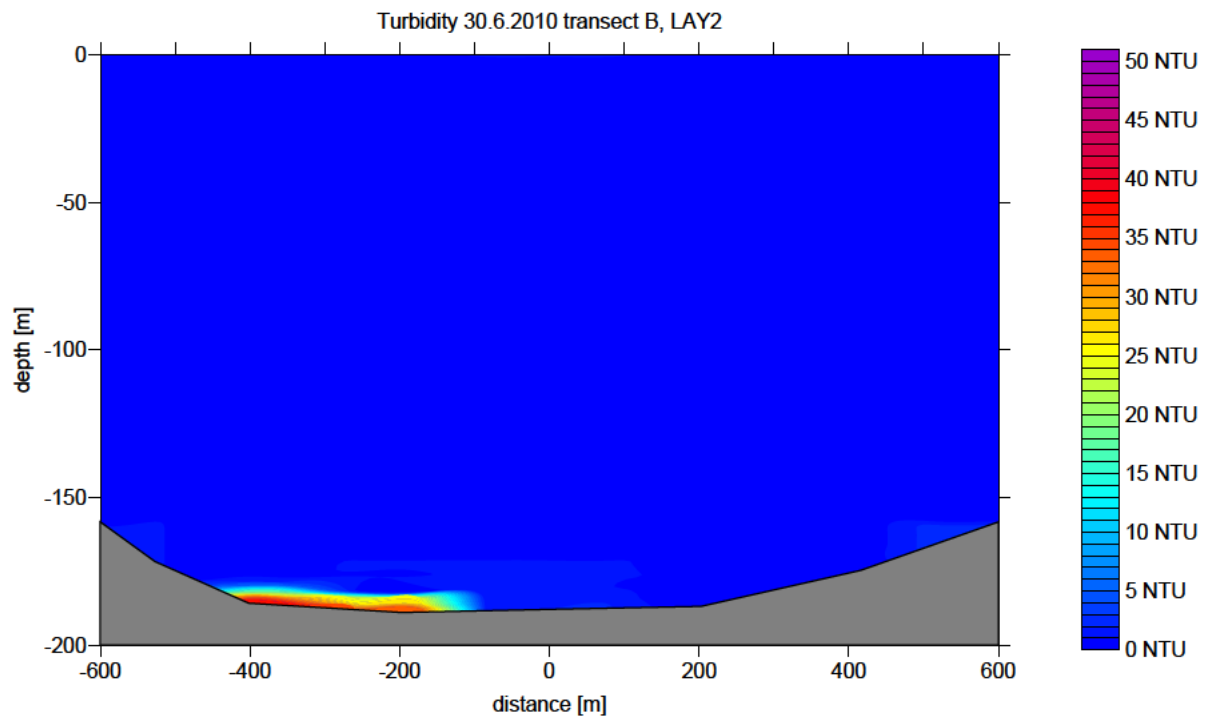
Figure 6.10 Vessel operated monitoring. Turbidity transect B (see Figure 4.4) perpendicular to the pipeline installation corridor at LAY 2 on 30th June. The zero distance point represents the location of the pipeline. Negative distances are measured towards south and positive ones towards north /26/.

Clearly elevated turbidity values near the bottom were recorded during vessel operated monitoring of the transect perpendicular to the pipeline, within less than 500 m distance from the pipeline alignment. The highest value was 37 NTU, recorded one metre above the seabed. Based on anchor logs, it is unlikely that anchoring would have caused this turbidity increase. Most probably this increase is attributed to vertical movement of partly buried pipe at the same touchdown point during a 45 minute repair on the pipelay barge. However, when taking into consideration the turbidity level, its occurrence near the bottom and prevailing unfavorable living conditions there, no harmful effects to biota are assessed to have been caused.

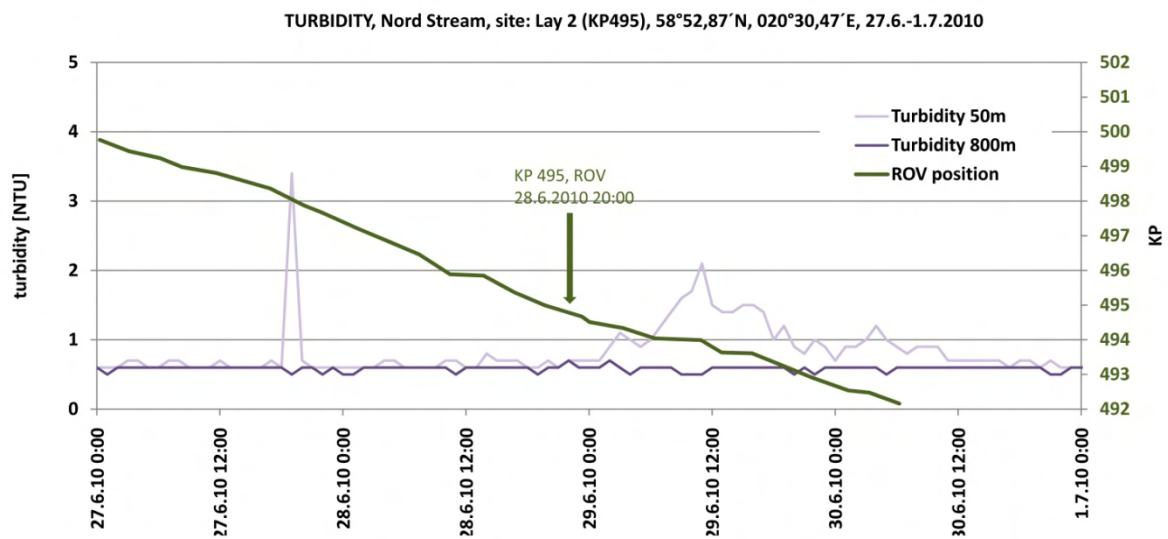
In Figure 6.11 the impacts of pipelay activities (anchor handling, pipeline touchdown and pipeline touchdown monitoring by ROV) on turbidity are seen when these actions were happening in the vicinity of the sensors. Small turbidity peaks were recorded at the nearest fixed sensor from the activity. The highest value measured 50 metres away from the pipeline on 27th June was 3.4 NTU lasting less than 2 hours. Another period when slightly elevated values were recorded by the same sensor was from the 29th – 30th June. During these days the turbidity increase was only approximately 1 NTU unit, compared to the results of the sensor furthest away. Values decreased to a background level within hours. For comparison, the highest value, 4 NTU, was measured on 17th July. By this time the pipelay activities were performed tens of kilometers away from the fixed sensors and the observed peaks cannot be attributed to these activities.

Figure 6.11 Turbidity recordings of the two fixed sensors from 27th June – 1st July 2010 at LAY2, when pipelay and pipeline touchdown monitoring by an ROV were conducted in the vicinity of the station /26/.

Monitoring results by fixed sensors showed that pipelay with an anchored lay barge caused minor short-term, turbidity peaks above the bottom, not far from the installation corridor. The highest value recorded 50 metres away from pipeline was low, 3.4 NTU. No general increase in turbidity was observed. The soft clay bottoms had no aerobic biota because of complete lack of oxygen.
