Nord Stream Munitions clearance in the Finnish EEZ

Final monitoring results on
Munition by munition basis

January 2011

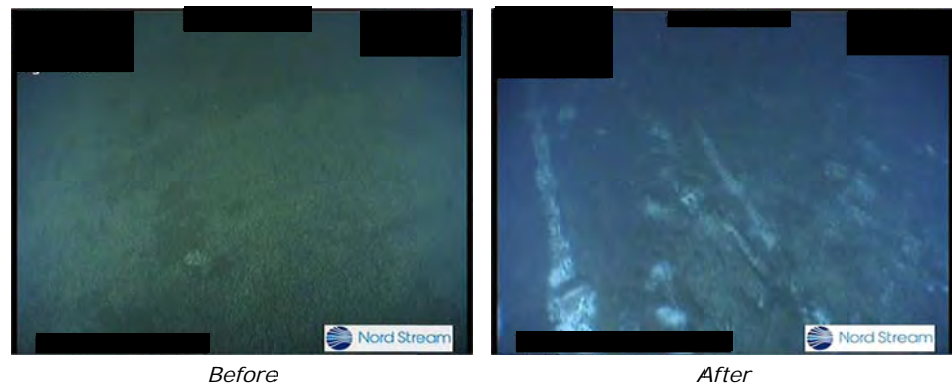
Figure A3.33c Images of cable EE-SF2; the image 'after' was taken after disposal of five FAB100 munitions (F37, F38, F38B, F38C, F38D) and 1st attempt F38E. Detonation of this munition could potentially impact the cable. Concern was raised that each inspection by ROV could cause slight scour to the seabed and hence exposure of the cable. It was therefore decided not to repeat the inspection after each detonation but after a number of detonations.

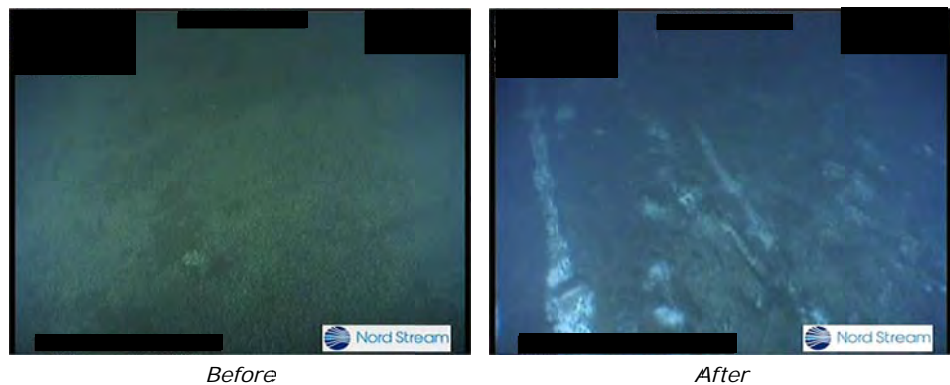
Figure A3.35c *Images of cable EE-SF2; the image 'after' was taken after disposal of five FAB100 munitions (F37, F38, F38B, F38C, F38D) and 1st attempt F38E. Detonation of this munition could potentially impact the cable. Concern was raised that each inspection by ROV could cause slight scour to the seabed and hence exposure of the cable. It was therefore decided not to repeat the inspection after each detonation but after a number of detonations.*

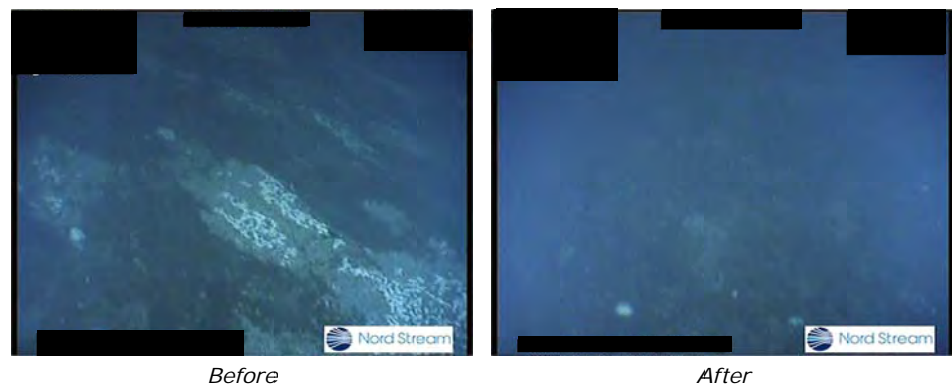
Figure A3.39c Images of cable EE-SF2; the 'before' image is taken before 2nd and final disposal of this target (F38E) but after disposal of five FAB100 munitions (F37, F38, F38B, F38C, F38D) and 1st attempt F38E; the 'after' image is taken after disposal of F38G and F38H. Detonation of this munition could potentially impact the cable. Concern was raised that each inspection by ROV could cause slight scour to the seabed and hence exposure of the cable. It was therefor decided not to repeat the inspection after each detonation but after a number of detonations.

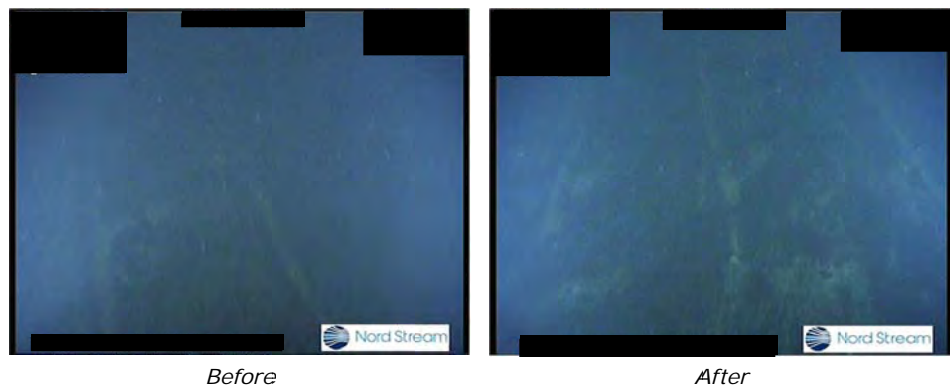
Figure A3.41c *Images of cable EE-SF2; the 'before' image was taken on 11 June 2010 after disposal of nine FAB100 munitions (F37 – F38G); the 'after' image was taken after disposal of all FAB100 munitions. Detonation of this munition could potentially impact the cable. Concern was raised that each inspection by ROV could cause slight scour to the seabed and hence exposure of the cable. It was therefor decided not to repeat the inspection after each detonation but after a number of detonations.*

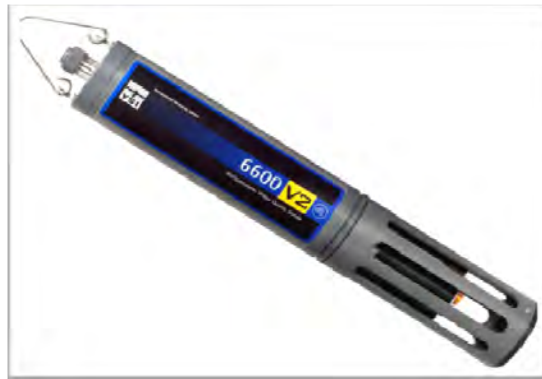
Figure 3. YSI multiparameter sonde.

Ranges, resolution and accuracy of the YSI sonde are listed in the Attachment 1. Position information was collected with a GPS.
