Nord Stream Project

</div>			Document Title					
			Environmental monitoring in Swedish waters, 2010					
			Company Representative : Werner Zirnig					
			Reference :					
PO. No. : PO10-1029			Document-No. G-PE-PER-MON-100-04100000					Rev. A
Contractor Representative : Neel Strøbæk								
Document Owner : Ramboll			Pipe line	Sub project	Discipline	Doc. Type	Originator ID	Unifier

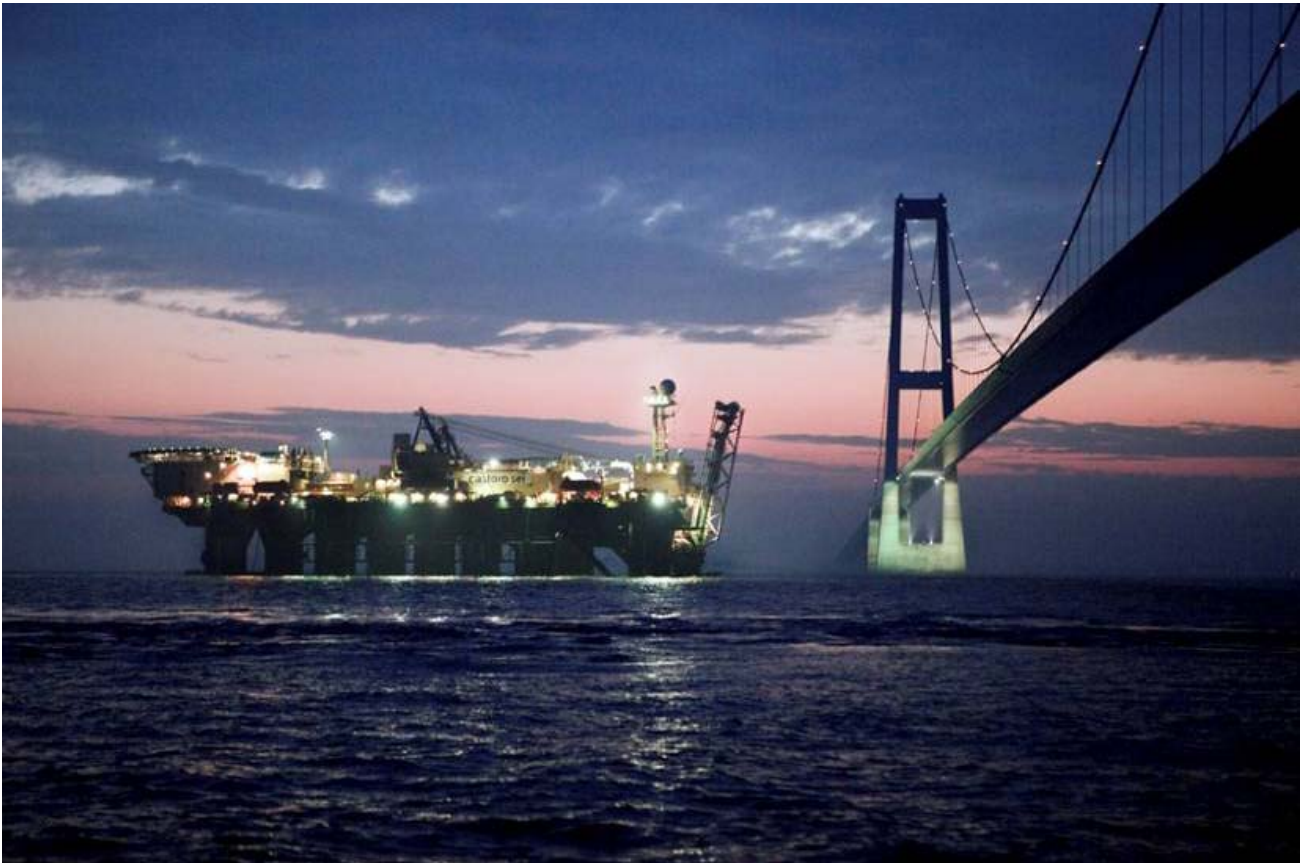
Figure 3.1 Castoro Sei passing the Great Belt Bridge early morning on 26 March 2010 on its way to pipe-lay work in the Swedish EEZ.

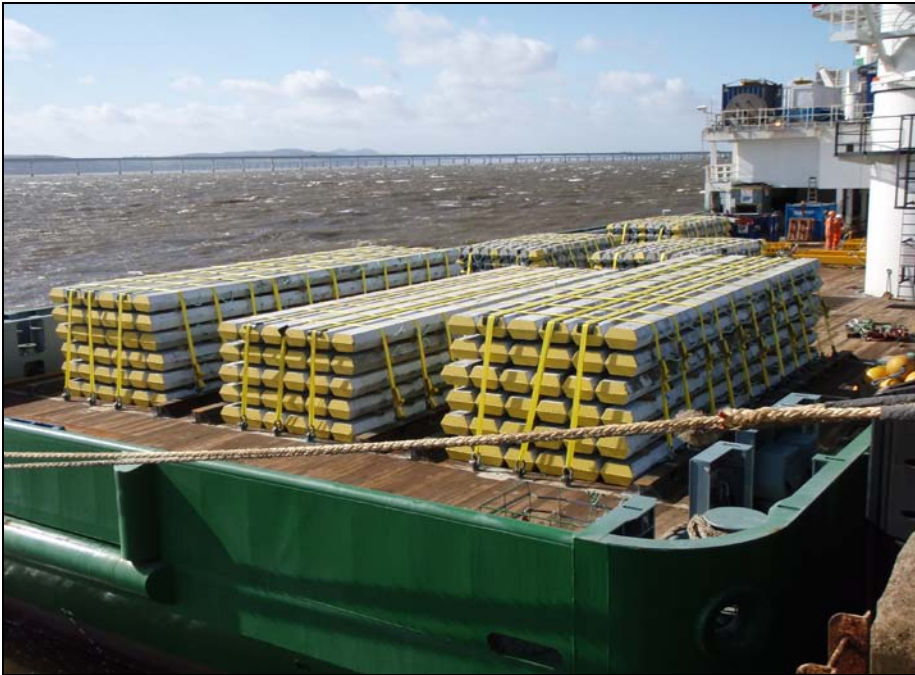
Flexible concrete mattresses have been selected for placement over the cables at the crossing locations to increase the bending radius imposed on the cables and to ensure a permanent vertical separation between the pipeline and the cables. In cases where the cables have been buried at a lesser depth, neoprene pads have been added to the lower surface of the mattresses. For some crossings, concrete beam mattresses have been selected for placement under the pipelines at locations adjacent to the crossing locations to provide additional bearing support to the pipeline thereby reducing the load on the cables at the crossing locations.

Figure 3.4 Beam mattresses prior to installation in the Swedish EEZ.

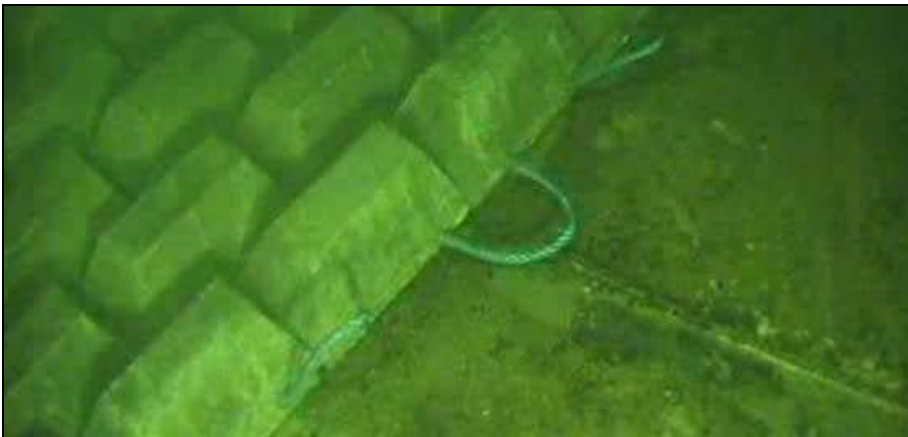
Due to the very hard seabed conditions, minimal embedment of the mattresses at the crossing location was done. Figure 3.5 and Figure 3.6 show the LV-S1 cable at the crossing point during the as-built and as-left surveys at KP 564.

Figure 3.5 LV-S1 cable at the crossing point during the as-built survey.

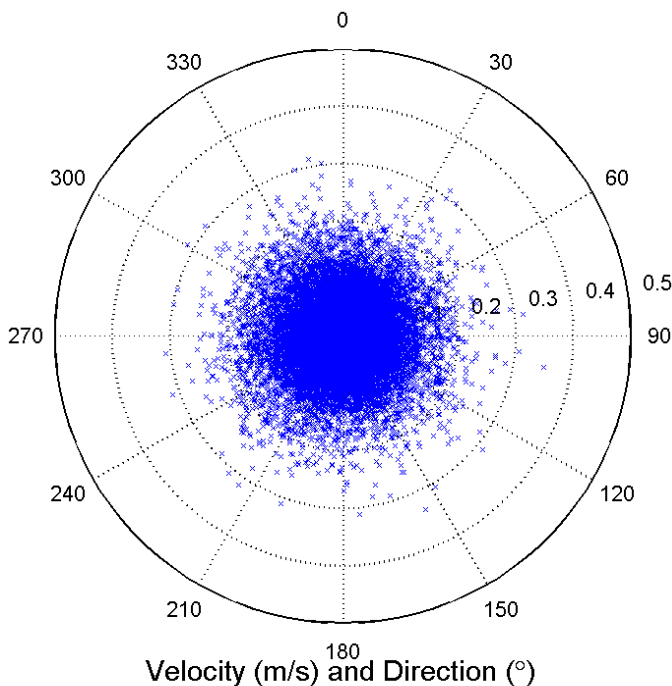
Unfortunately, the bottom ADCP data is missing during the period of saline inflow. No signal is found in the AWAC data facing up, however, this instrument was situated above the inflow. Figure 4.9 shows a current rose from the bottom cell (2 m above the seabed) based on all the data between January to October 2010. Data have been averaged to remove noise.

Figure 4.9 Current rose diagram, January to October 2010, 2 m above seabed at the fixed monitoring station, KP 1036.

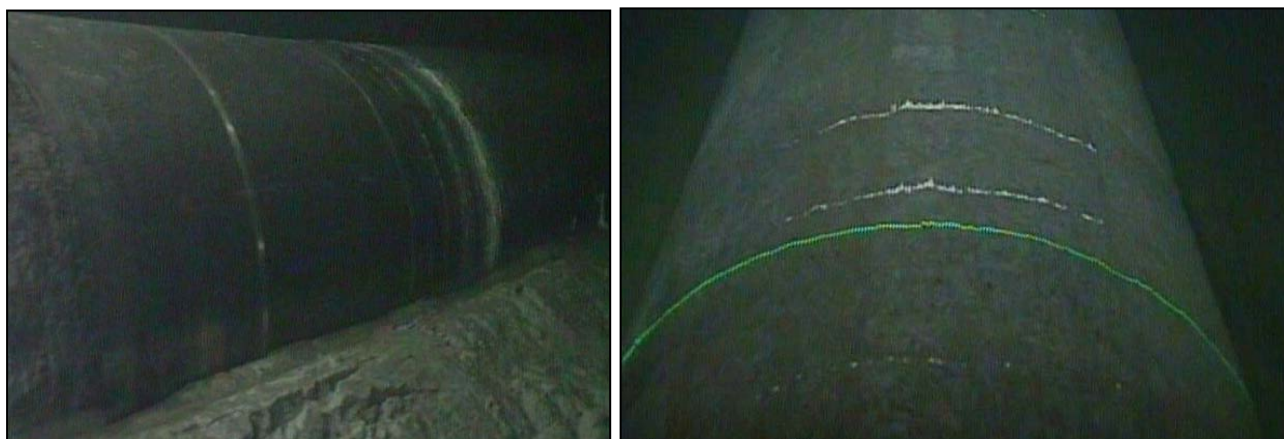
Figure 4.13 Left: Pipeline buckle arrestor observed at KP 513. Right: Minor concrete damage observed at KP 512.

The initial results regarding the position of the pipeline, in height and width within the Swedish EEZ, show that the pipeline in general appears to be stable and well supported. The results also indicate that the pipeline has been laid as planned within the 15 meters wide installation corridor, with only three exceptions: Max. DCC (Distance of Cross Course) of ± 7.84 m (East side) at KP 507, Max. DCC of ± 10.04 m (East side) at KP 511, and Max. DCC of ± 11.84 m (East side) at KP 512.
