## 5. MONITORING ACTIVITIES

This chapter describes the environmental monitoring activities performed during 2010. Monitoring was performed related to the following construction activities: munitions clearance, rock placement, cable mattress installation, pipelay with an anchored lay barge and pipelay with DP lay barge. Also long term water quality as background information has been monitored throughout the year starting from November 2009. Monitoring of munitions clearance started on 6<sup>th</sup> December 2009, when the clearance operation started.

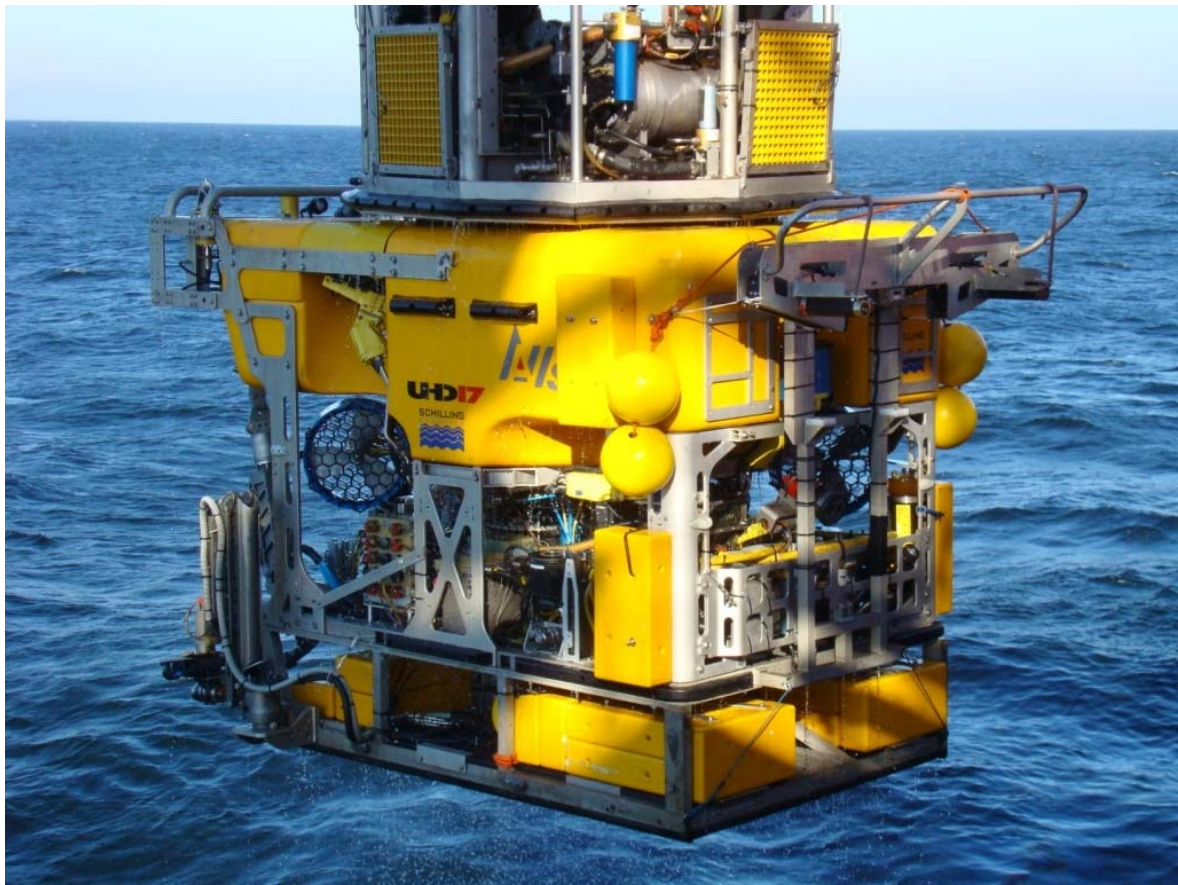
**Figure 5.3** A picture of an ROV used in connection with seabed studies

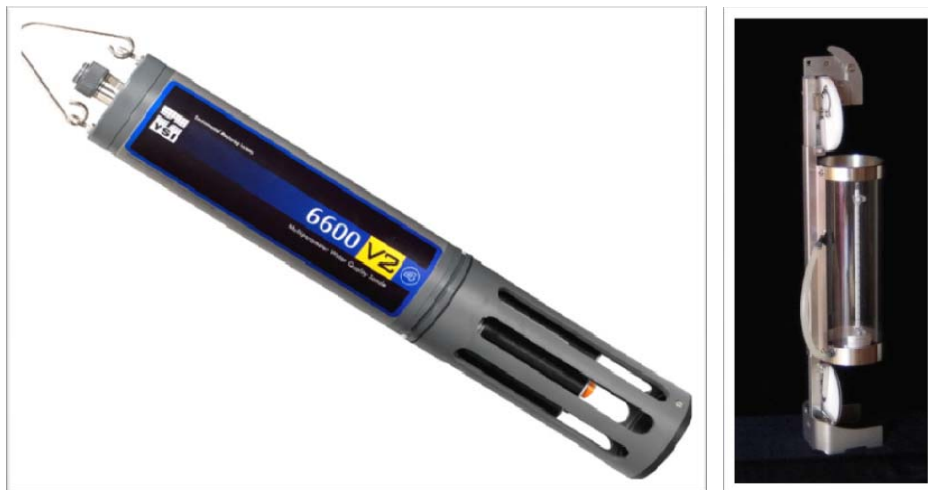
**Figure 5.4** Self-logging YSI multiparameter sonde used in vessel operated automatic sensing (left) and a Limnos water sampler (right) /39, 40/

Vessel operated automatic sensing has been carried out with a multi parameter sonde that measures turbidity, temperature, conductivity and depth /39 – 41/. This automatic self-logging instrument (Figure 5.4) is lowered from a support vessel from sea surface to bottom along pre-planned transect lines. Data is gathered with 20 to 50 cm intervals. According to the monitoring programme /2/, each transect is measured two to three times, depending on the construction activity.

Monitoring at Fixed stations has been performed with self-logging YSI-6600 and YSI-600 series Deep Water multiparameter sondes (Figure 5.4 above). The sensors measure turbidity, temperature, conductivity and oxygen concentration. Sensors are anchored approx. 1-2 m above the seabed for a certain period of time and gather information every 60 minutes. Sensors are anchored to the seabed before construction activity and recovered after the activity is completed. Sensors are equipped with acoustic releasers for recovery of the instruments (Figure 5.5).

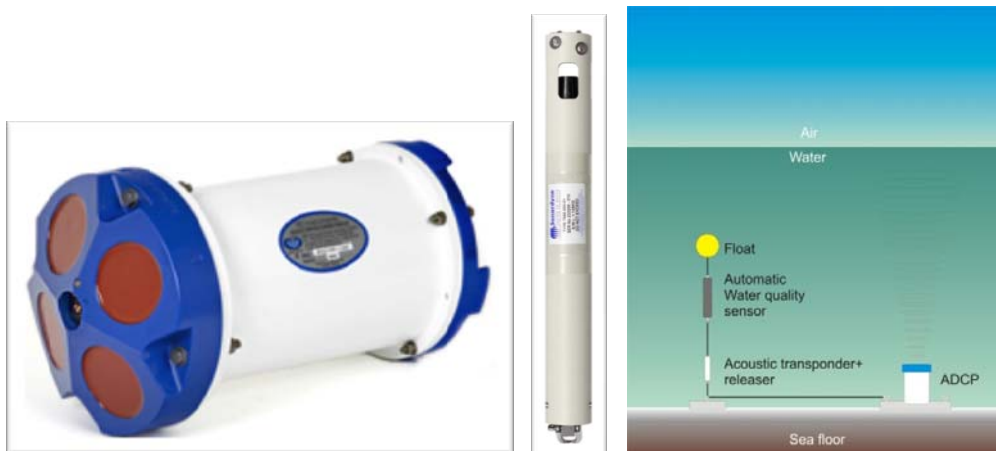
**Figure 5.5** ADCP equipment (RD-Instruments Workhorse Sentinel ADCP) used in current monitoring, (left). Sonardyne acoustic releaser with a distance transponder (middle). Schematic placement of fixed sensor and ADCP (right). /40, 41/

An ADCP (Acoustic Doppler Current Profiler) has been attached to fixed stations at some monitoring locations to monitor changes in the current field (current speed and direction) over the entire water column. The ADCP has been placed in close proximity of fixed sensor to the seabed (Figure 5.5) and measure the current field from bottom to surface with a two metre vertical resolution at 60 minute intervals. One measurement is taken every 60 seconds and the averaged value is logged every 60 minutes, which allows the current velocity to be measured with accuracy better than 1 cm/s.

Schematic presentation of fixed sensor and ADCP on the seabed is presented in Figure 5.5 (right).

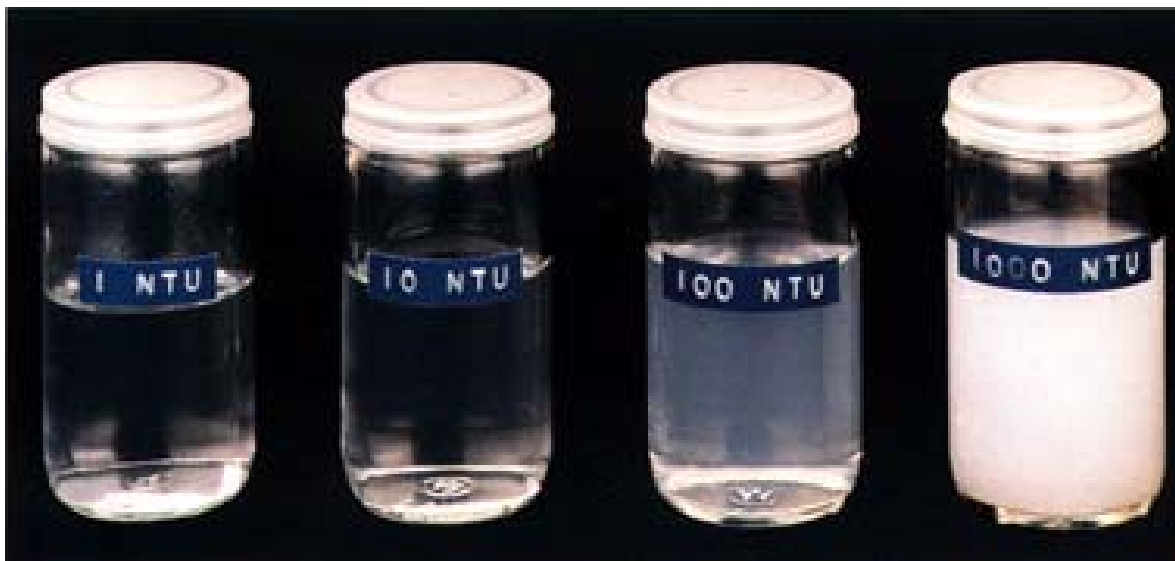
**Figure 6.1** A series of water samples of different turbidity shown in NTU unit

When reading the water quality results measured in connection with the different construction activities, it is worth noting that the value of 10 NTU is considered to be the lowest limit at which turbidity is visible to the human eye (see Figure 6.1).

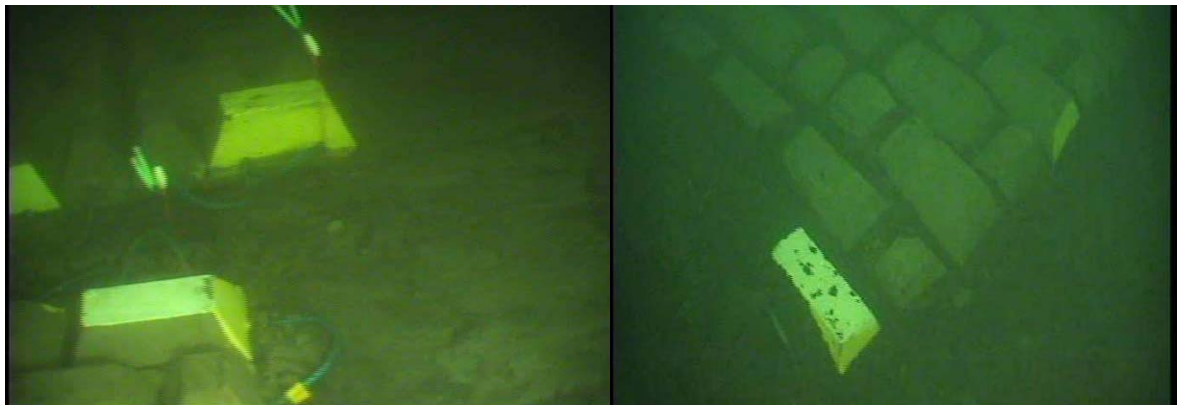
**Figure 6.25** Left, a gap of approximately 40 cm between two mattresses at the Unknown cable crossing (KP 234, second pipeline (south-east)). Right, an example of mattress embedment. Estimated embedment of the mattresses was 0.4 m at maximum.

- Estimated embedment of the mattresses was 0.4 m at maximum, depending on the seabed type. Some of the mattresses were partially covered by the sediment after the installation (Figure 6.15).

- At the Pangea Seg 3 (KP 442, second pipeline (south-east)) one corner of the mattresses had settled in a naturally occurring depression on the seabed that was approximately 0.4 m deep. /14 - 31/

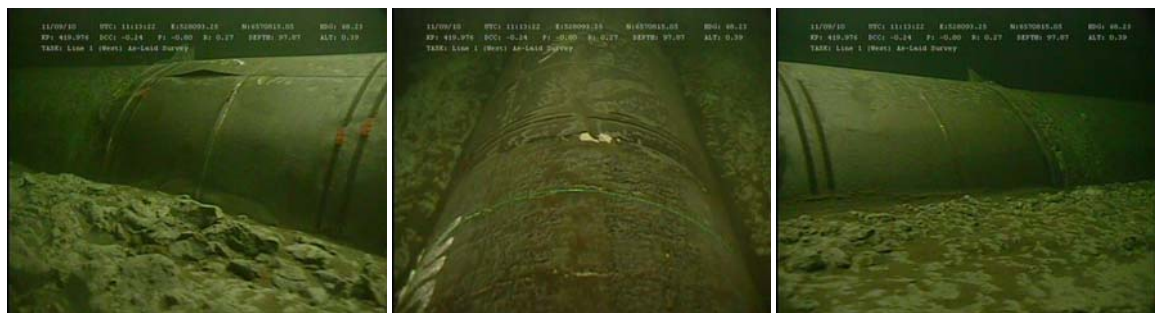
**Figure 6.28** Field joint showing approximate 50% pipeline embedment at KP 419.975

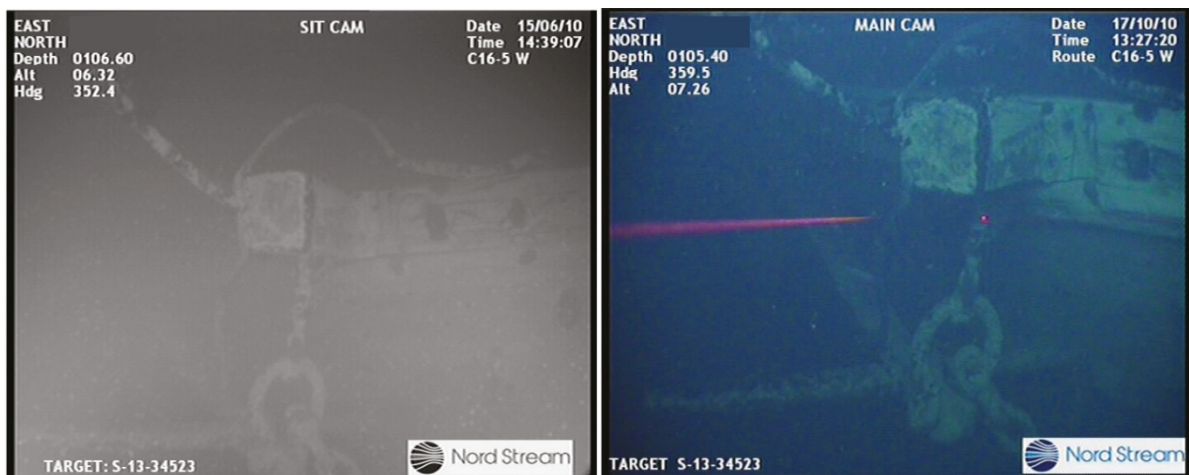
**Figure 6.33** Still image of the wreck S-13-34523 from pre-lay (left) and post-lay (right) survey. Port anchor and anchor outrigger. /49/

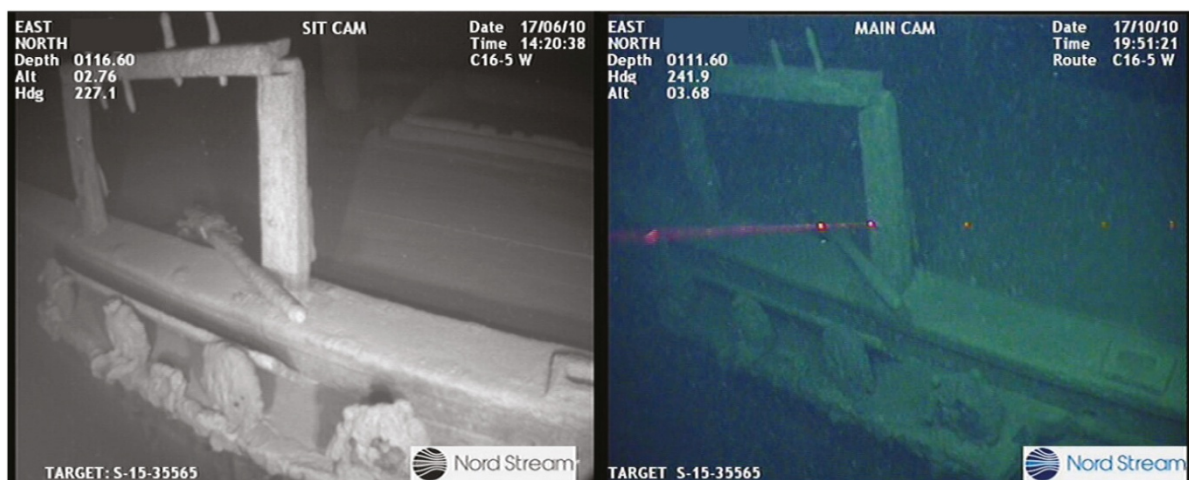
**Figure 6.34** Still image of the wreck S-15-35565 from pre-lay (left) and post-lay (right) survey. Rope attachment. /50/
