Nord Stream Project

</div>			<div>Document Title</div> <div>Environmental monitoring in Swedish waters, 2013</div>					
Company Representative : Samira Kiefer Andersson								
Reference :			Document-No. G-PE-PER-MON-100-04100013				Rev. A	
PO. No. : PO13-1150								
Contractor Representative : Henrik Juhl								
Document Owner : Ramboll			Pipe line	Sub project	Discipline	Doc. Type	Originator ID	Unifier

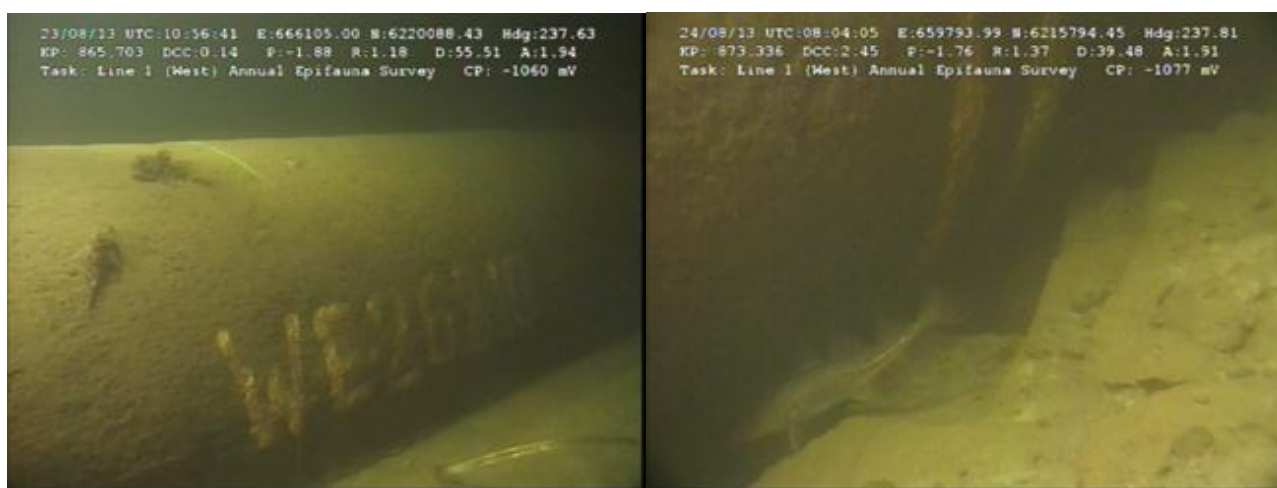
In 2013, the video recordings from the four analysed areas on Line 1 in Swedish waters revealed an establishment of blue mussels in the NMR_{new} area and a possible establishment of blue mussels in the HNB area (see Figure 4.4 and Figure 4.5). One mobile species of epifauna, the crustacean *Saduria entomon*, was identified to be present on and next to the pipeline in higher numbers compared with previous surveys carried out in 2011 and 2012. In addition, two species of fish, shorthorn sculpin and cod, were observed on and in close vicinity of the pipeline. No fish were observed in 2011.

Figure 4.4 Still photos from the west side of the pipeline (Line 1) at HNB (left) and NMT (right) in 2013. Two shorthorn sculpin and two *Saduria entomon* are visible in the HNB photo; one cod is visible in the NMT photo.

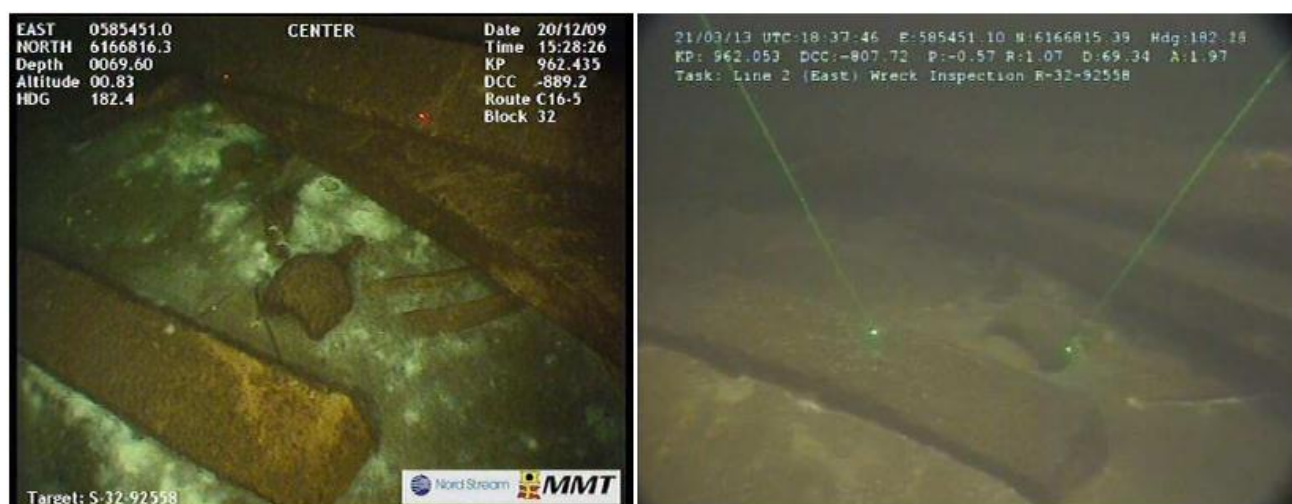
The wreck ID R-32-92558, lying at an approximate bearing of 315°, consists of large amounts of debris, mostly of planks and other pieces of wood such as ribs which probably belong to the wreck. In addition, some bowls, a chain an anchor forward windlass, a rudder and a tiller were found (see

The revisited events and the overall impression of the wreck are consistent with the survey results from the pre-lay investigation conducted in 2009. Visibility during this inspection period was comparatively worse than during the pre-lay survey. The position and condition of the wreck ID R-32-92558 appears to be unchanged and the comparison of images and positional data demonstrates that Line 2 (East) installation had no impact on wreck ID R-32-92558. From the evidence available it does not appear as though the wreck site has been disturbed since the pre-lay inspection conducted in 2009 (Ref. /25/).

Figure 5.3 Wreck R-32-92558, Event ID 82 – debris including a possible bottle. Photo before construction left (pre-lay Line 1 inspection, 20 December 2009) and after construction right (post-lay Line 2 inspection, 21 March 2012). From Ref. /25/.

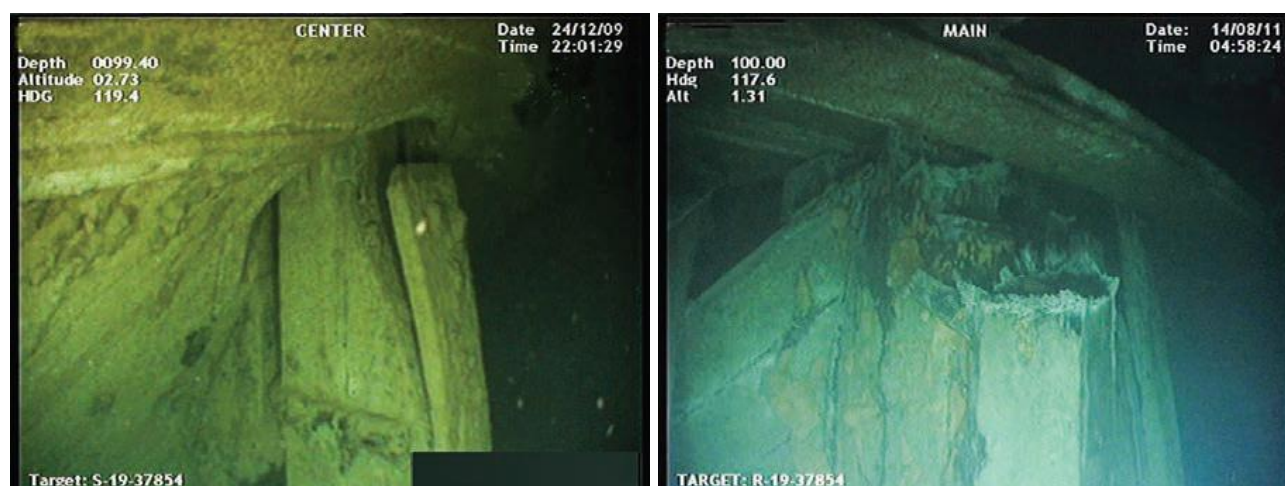
The analysis showed that one wreck (R-19-37854, see Section 5.2.2) had been damaged by an anchor cable (see Figure 5.4). The damage was mainly to the deck level, while the hull remains relatively intact. The anchor cable caused objects to break away from the wreck and in some cases these parts were not found.

Figure 5.4 Rudder of R-19-37854, before (left, 2009) and after (right, 2011) damage caused by an anchor cable during construction (from Ref. /26/).
