Nord Stream Environmental Impact Assessment Documentation for Consultation under the Espoo Convention

Nord Stream Espoo Report: Key Issue Paper Maritime Cultural Heritage

February 2009

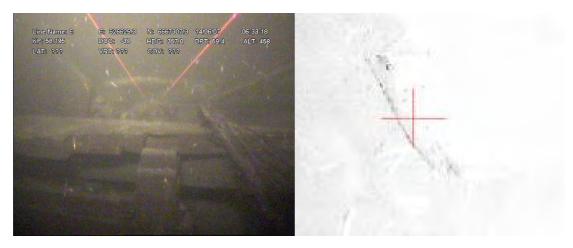
Figure 2.4 SSS image and ROV footage from the wreck 8-03-5827

- 8-03-5827 Wooden sailing vessel. Identified from SSS and visually inspected by ROV (situated closest to the East pipeline)
- 8-03-2167 (alternative ID 03-5W) Partially collapsed wooden wreck, approx. 25 m long.
 Galley with brick oven in good condition. The wreck is identified from SSS data and visually inspected by ROV. It is situated closest to the West pipeline

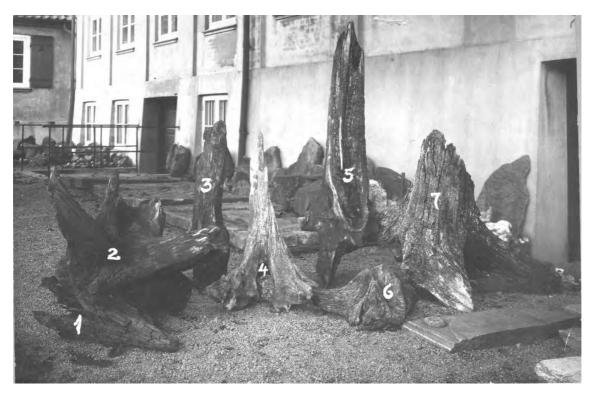
Figure 2.10 Tree roots from submerged forests around Bornholm. Picture: Courtesy of Bornholm Museum

Ancient submerged forests have for many years been encountered by fishermen and aggregate extractors working in the waters around Bornholm. Although areas with the remains of ancient forests as such are not usually prioritised with respect to heritage protection, the stumps of submerged trees (particularly oak trees) are of archaeological interest as they can possibly be dated, thus providing valuable information on sea-level changes in the area. Almost all known submerged forests are in depths of less than 20 m, although some occur in deeper water (20-40 m) /14/, /15/.
